# MASS MOVEMENT RESPONSE TO FOREST MANAGEMENT IN THE CENTRAL OREGON COAST RANGES

By Stuart Gresswell • David Heller • Douglas N. Swanston

### **RESOURCE BULLETIN PNW-84**

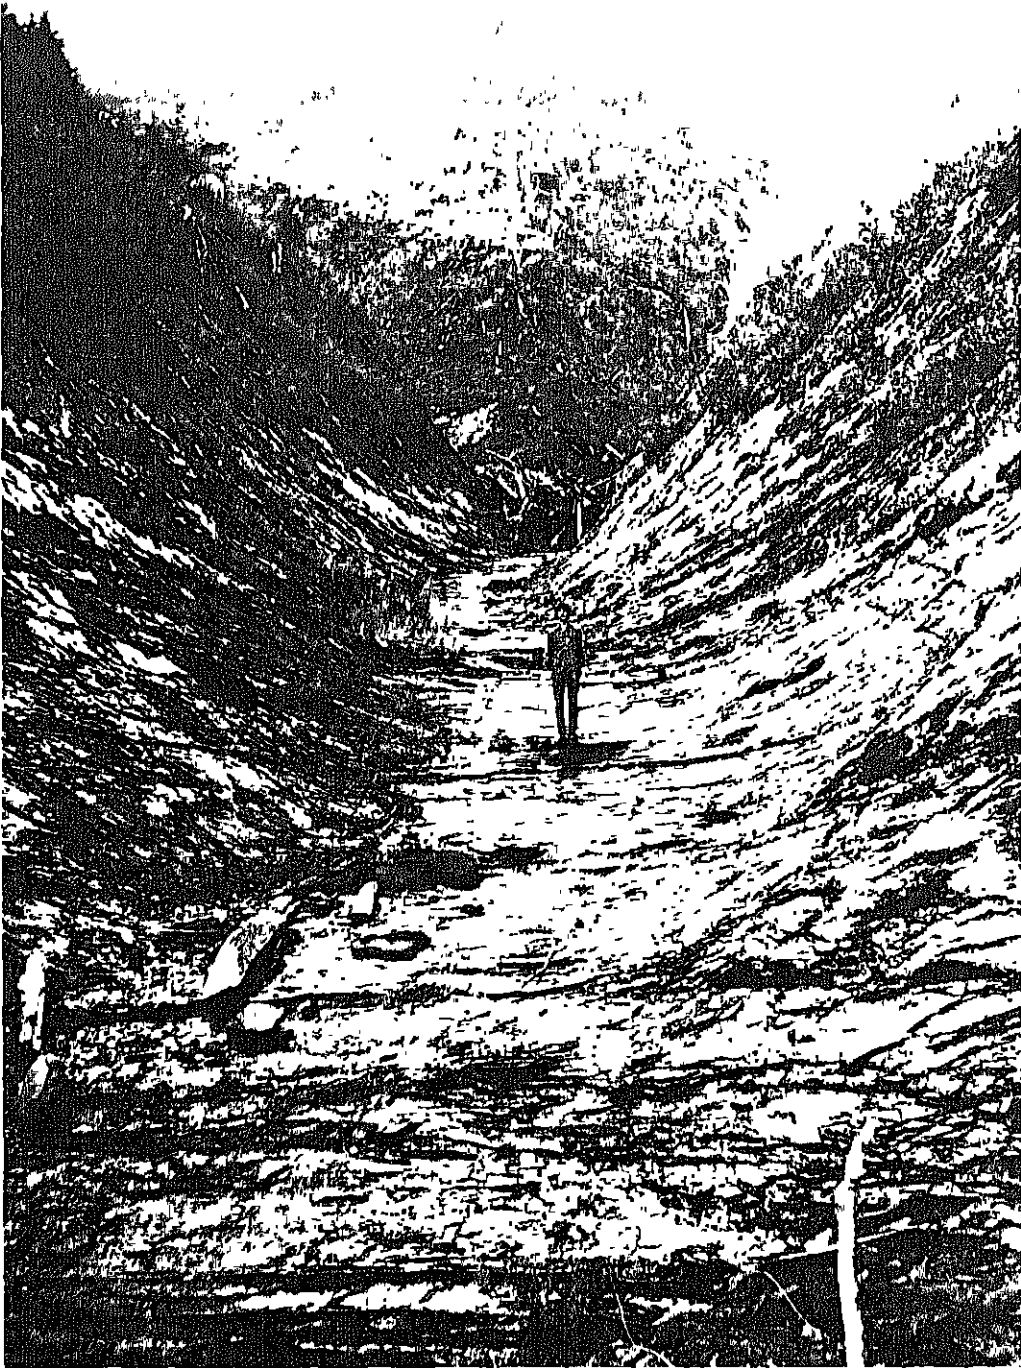
Mechanical scouring was the clearest impact to identify and define during the inventory (figure 7). It was possible to correlate scour directly with failure category. Thus, of the total length of channel scour observed (91,236 feet or 17.28 miles), 52 percent (47,395 feet or 8.98 miles) occurred as the result of in-unit failures. Road related failures accounted for 29 percent of about 26,140 feet (4.95 miles) of scour. Natural failures produced 19 percent or 17,700 feet (3.35 miles) of scour. All of these channel scour estimates are conservative.

Figure 7.--Channel scour in a class I stream result from a debris torrent.
